Site Name FAIRSON AVE BLOCKBUSTER VIDEO

DocumentType Site Assessment Rpt (SAR)

LIMITED SITE INVESTIGATION

Fairson Avenue Blockbuster Video
102 Fairson Avenue
Salisbury, Rowan County, North Carolina

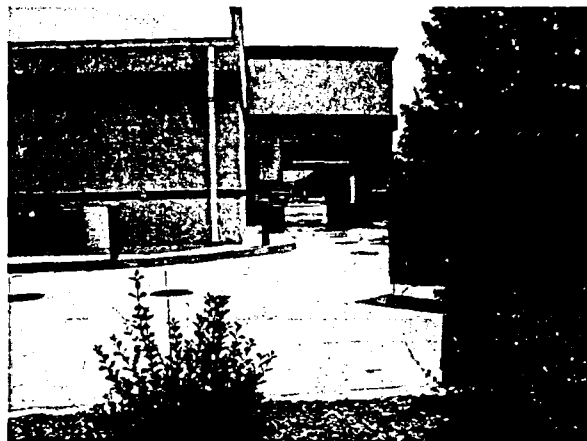
Photo #16 Photograph non-hazardous carwash detergent drums and carwash located north adjacent to the site.
